CASE STUDY LYDLINCH BRIDGE – BUILT 1942 AND IN GREAT CONDITION

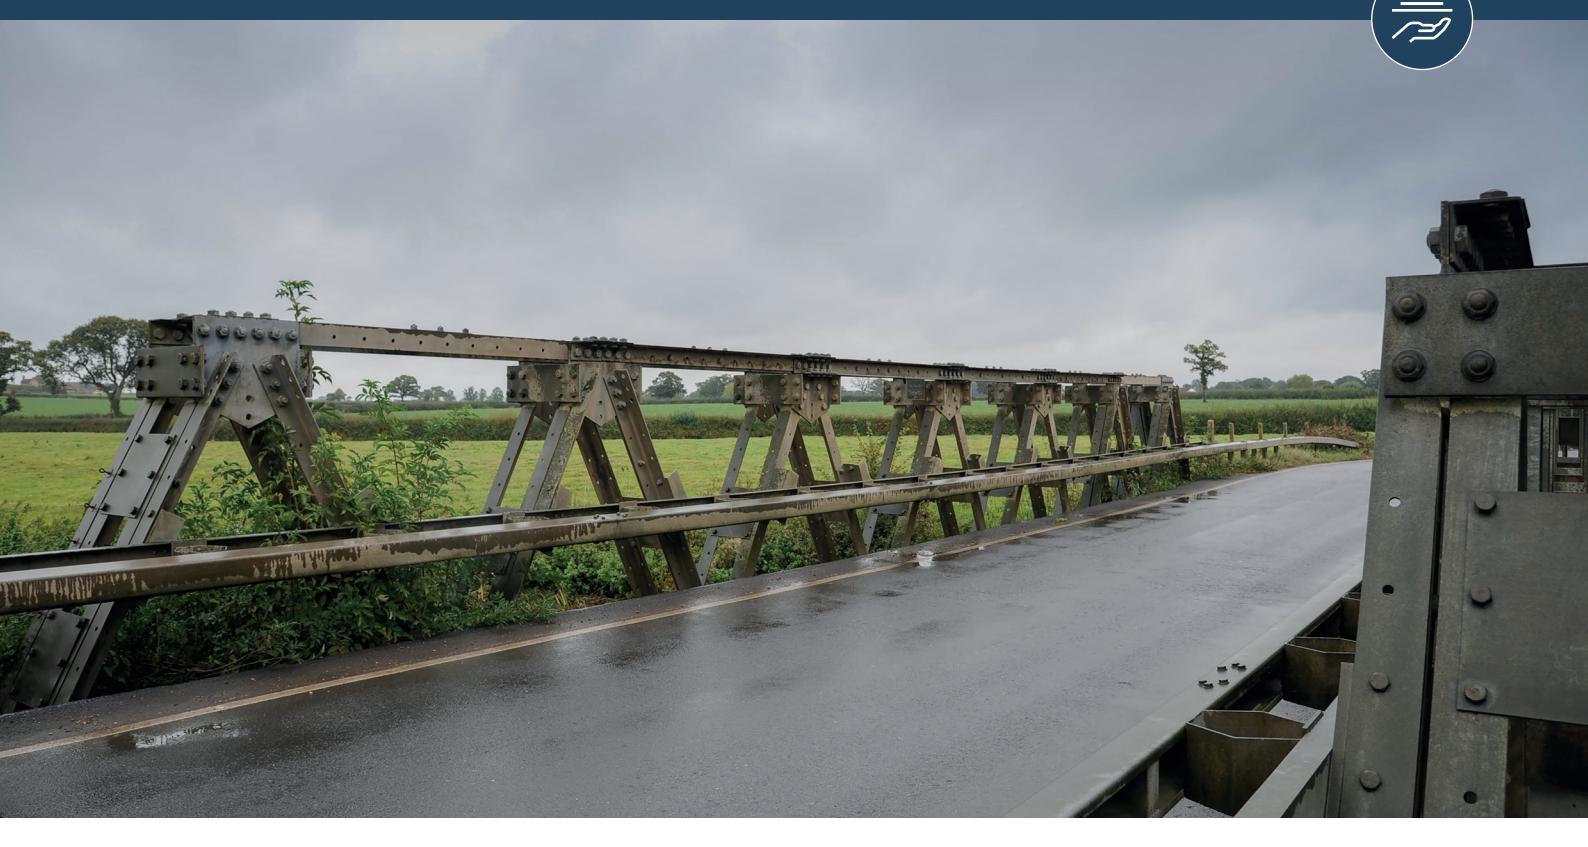
One such route, the A357 through Dorset, needed to be improved at Lydlinch. The picturesque narrow stone bridge over the River Lyden would not withstand the weight of heavy tanks. In 1942, Canadian army engineers erected a temporary galvanized steel Callender-Hamilton bridge alongside the older structure. The tanks and heavy equipment were diverted over the galvanized bridge on their way to Europe. The bridge was not intended to be a permanent structure but has stayed in service having been passed into Dorset County Council's control. It has carried the road's eastbound traffic ever since.

The bridge was inspected in 2014 and was in very good condition.

The components inspected included the main truss diagonals, joining plates and some bolt heads. Average coating thicknesses on the diagonal trusses ranged from 126µm to 167µm. On the plate sections the average thicknesses were 131µm to 136µm. On bolt heads average galvanized coating thicknesses ranged from 55µm to 91µm.

The strengthening consisted of bolting 'T' sections to the existing transverse deck beams and the addition of some longitudinal beams but the two main trusses were left as they were in 1942. On a few sections where a lot of cutting and readjustment of design had taken place, the sections were re-galvanized.

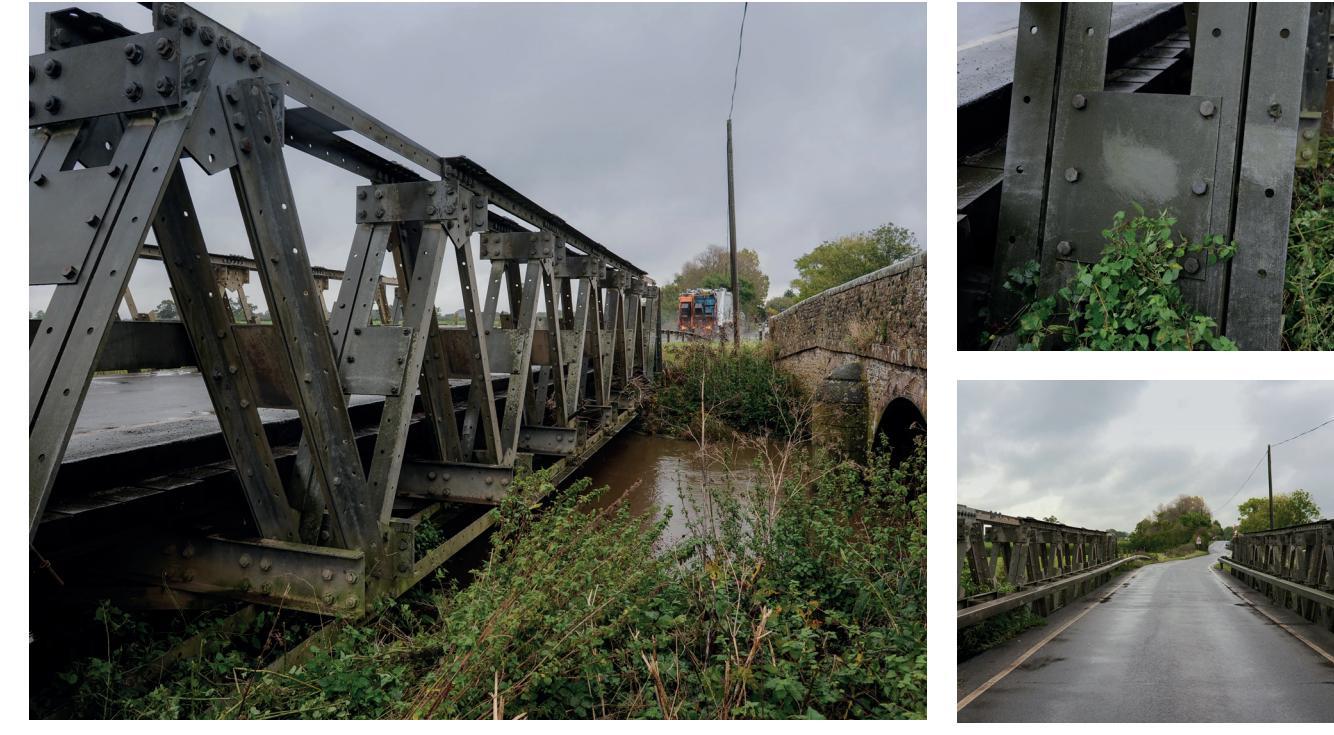
Having started life as a temporary structure, the Callender-Hamiliton bridge at Lydlinch, is still in good condition 78 years after it was first erected and can be expected to provide a life well in excess of 100 years.
